FINAL REPORT  
MAY 1995

REPORT NO. 94-26

ENHANCED WOOD PALLET  
EVALUATION

VALIDATION ENGINEERING DIVISION  
SAVANNA, ILLINOIS 61074-9639

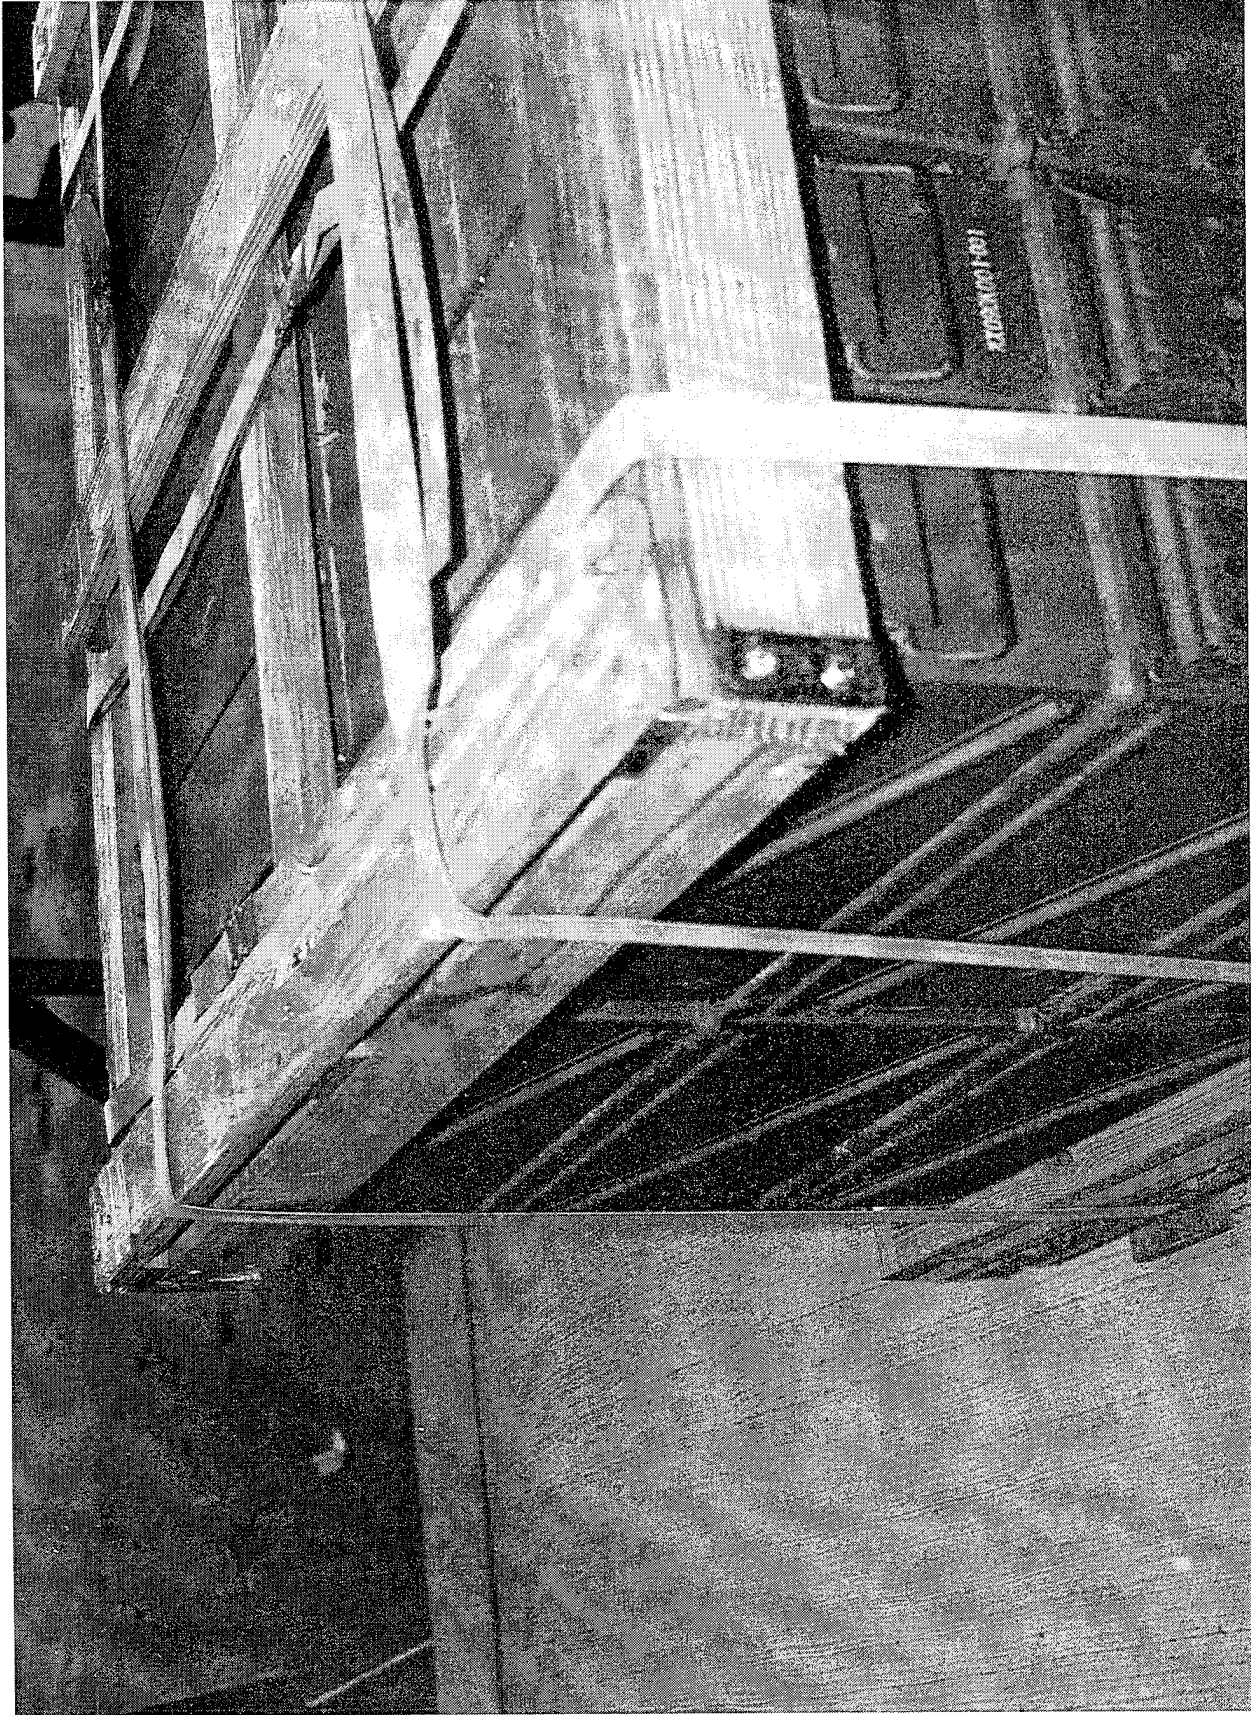
U.S. ARMY DEFENSE AMMUNITION CENTER AND SCHOOL - SAVANNA, IL	
PHOTO NO. SCN94-223-4465. This photo shows a closeup view of a damaged 1- by 4-inch lumber on the top pallet adapter.

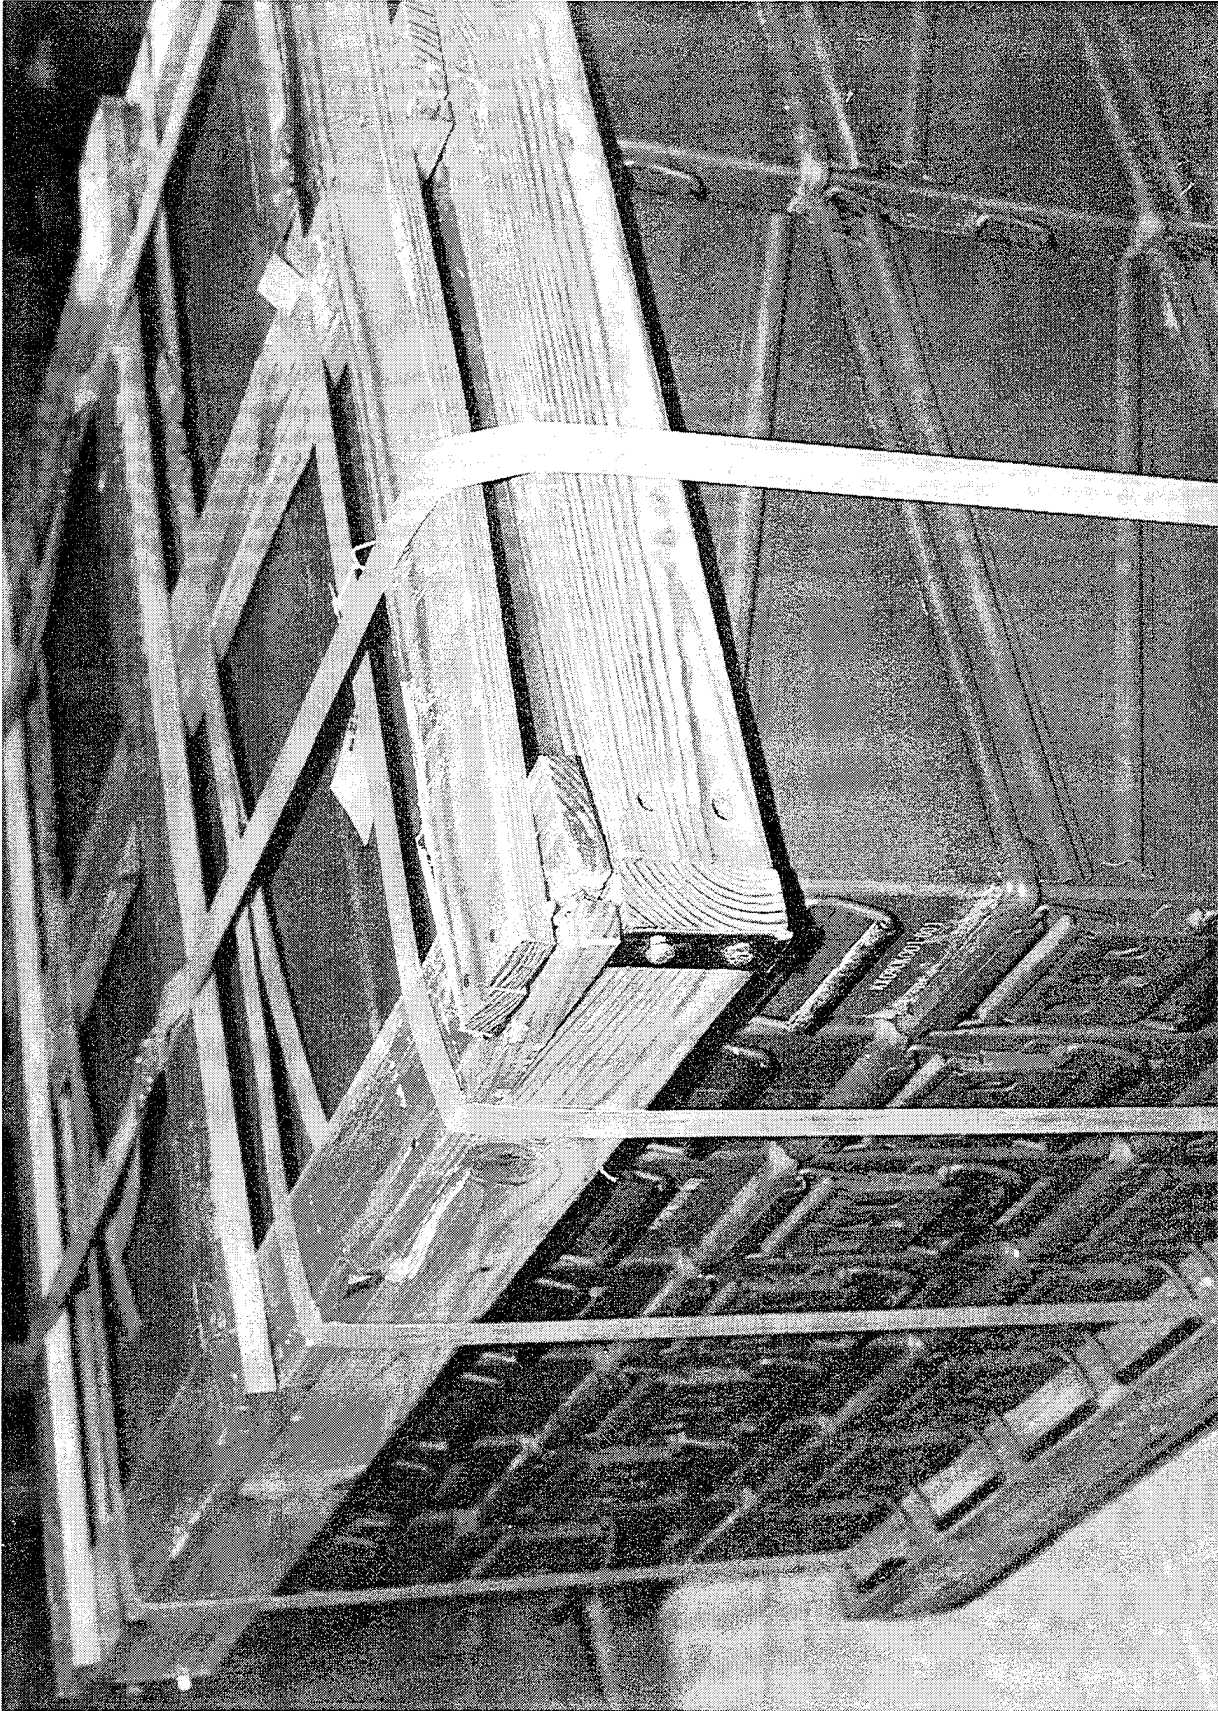
PHOTO NO. SCN94-223-4463. This photo shows a closeup corner view of damage to the top pallet adapter.

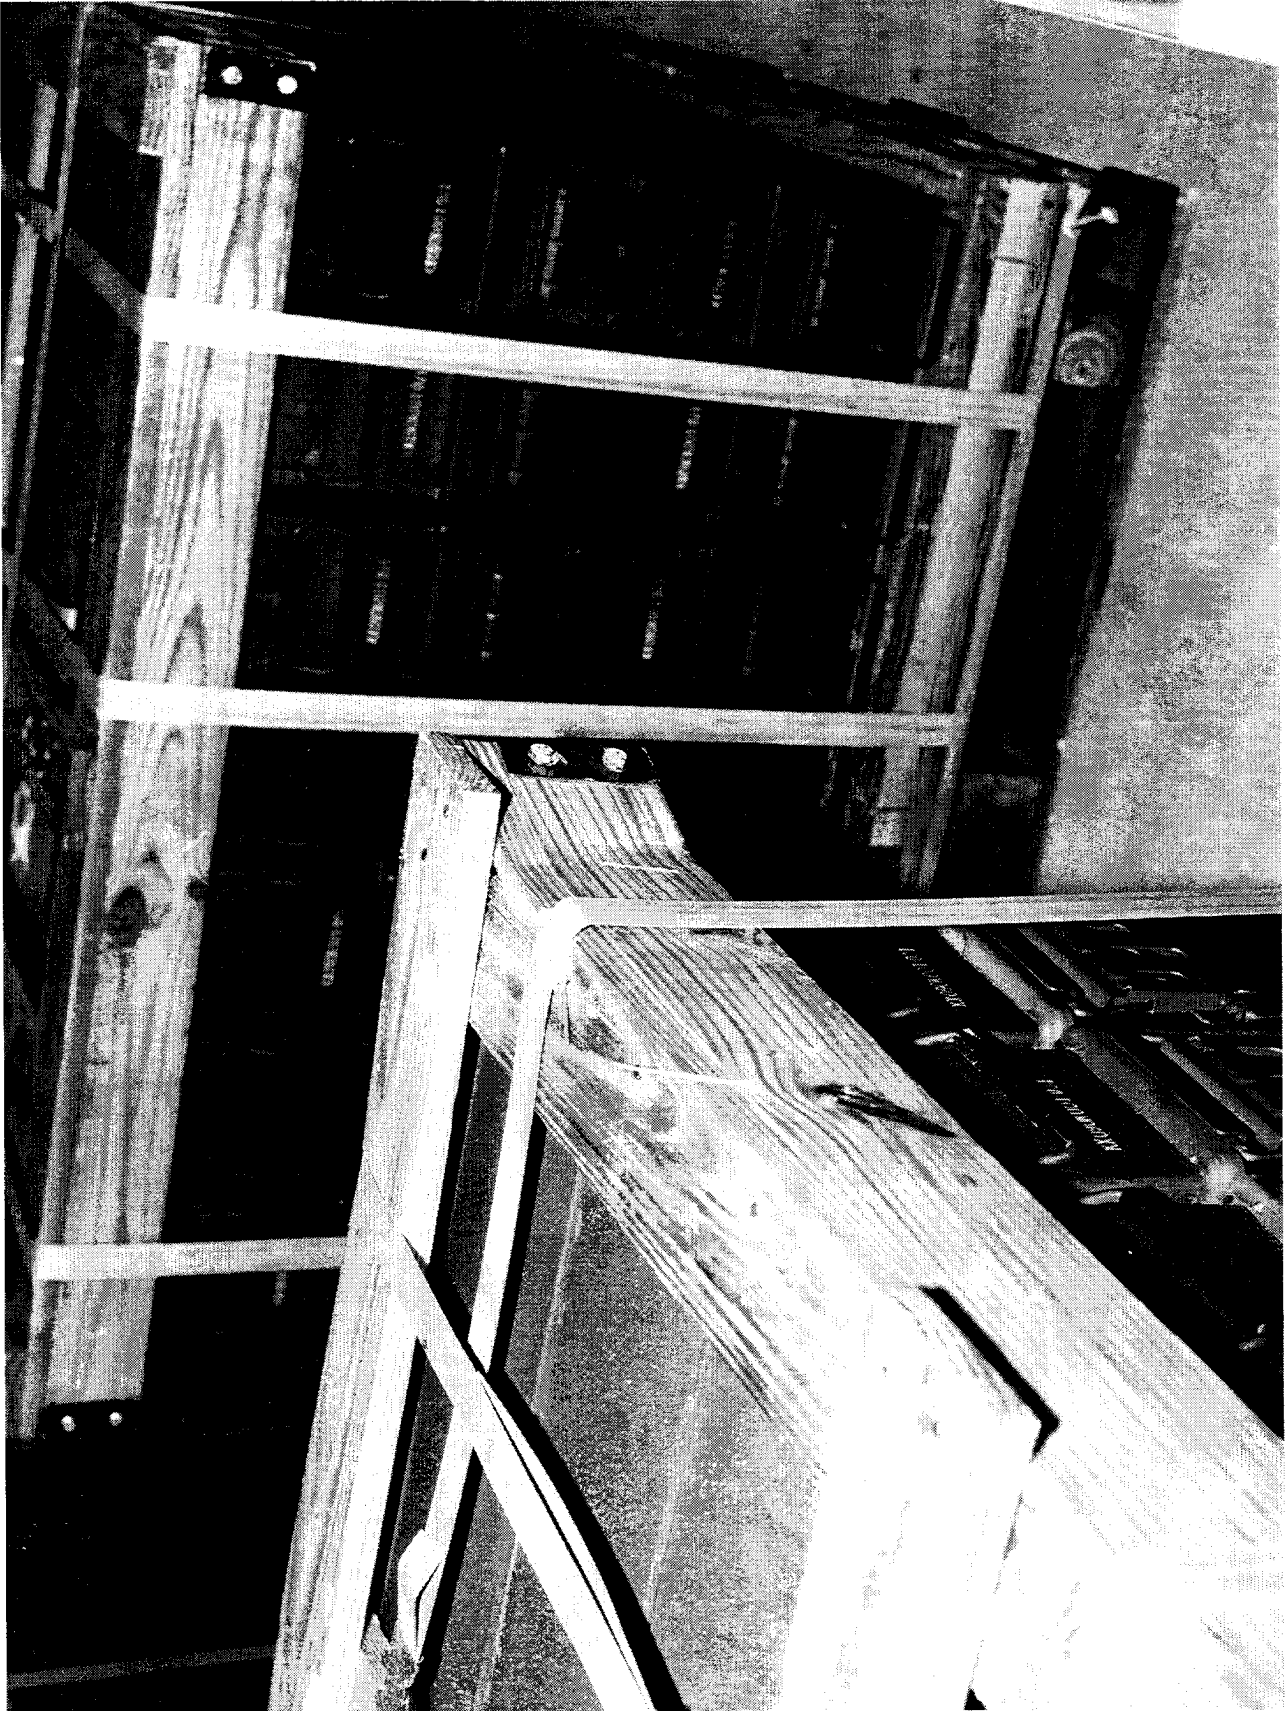
PHOTO NO. SCN94-223-4462. This photo shows a closeup view of the top pallet adapter with corner bolts being pulled from the top frame.

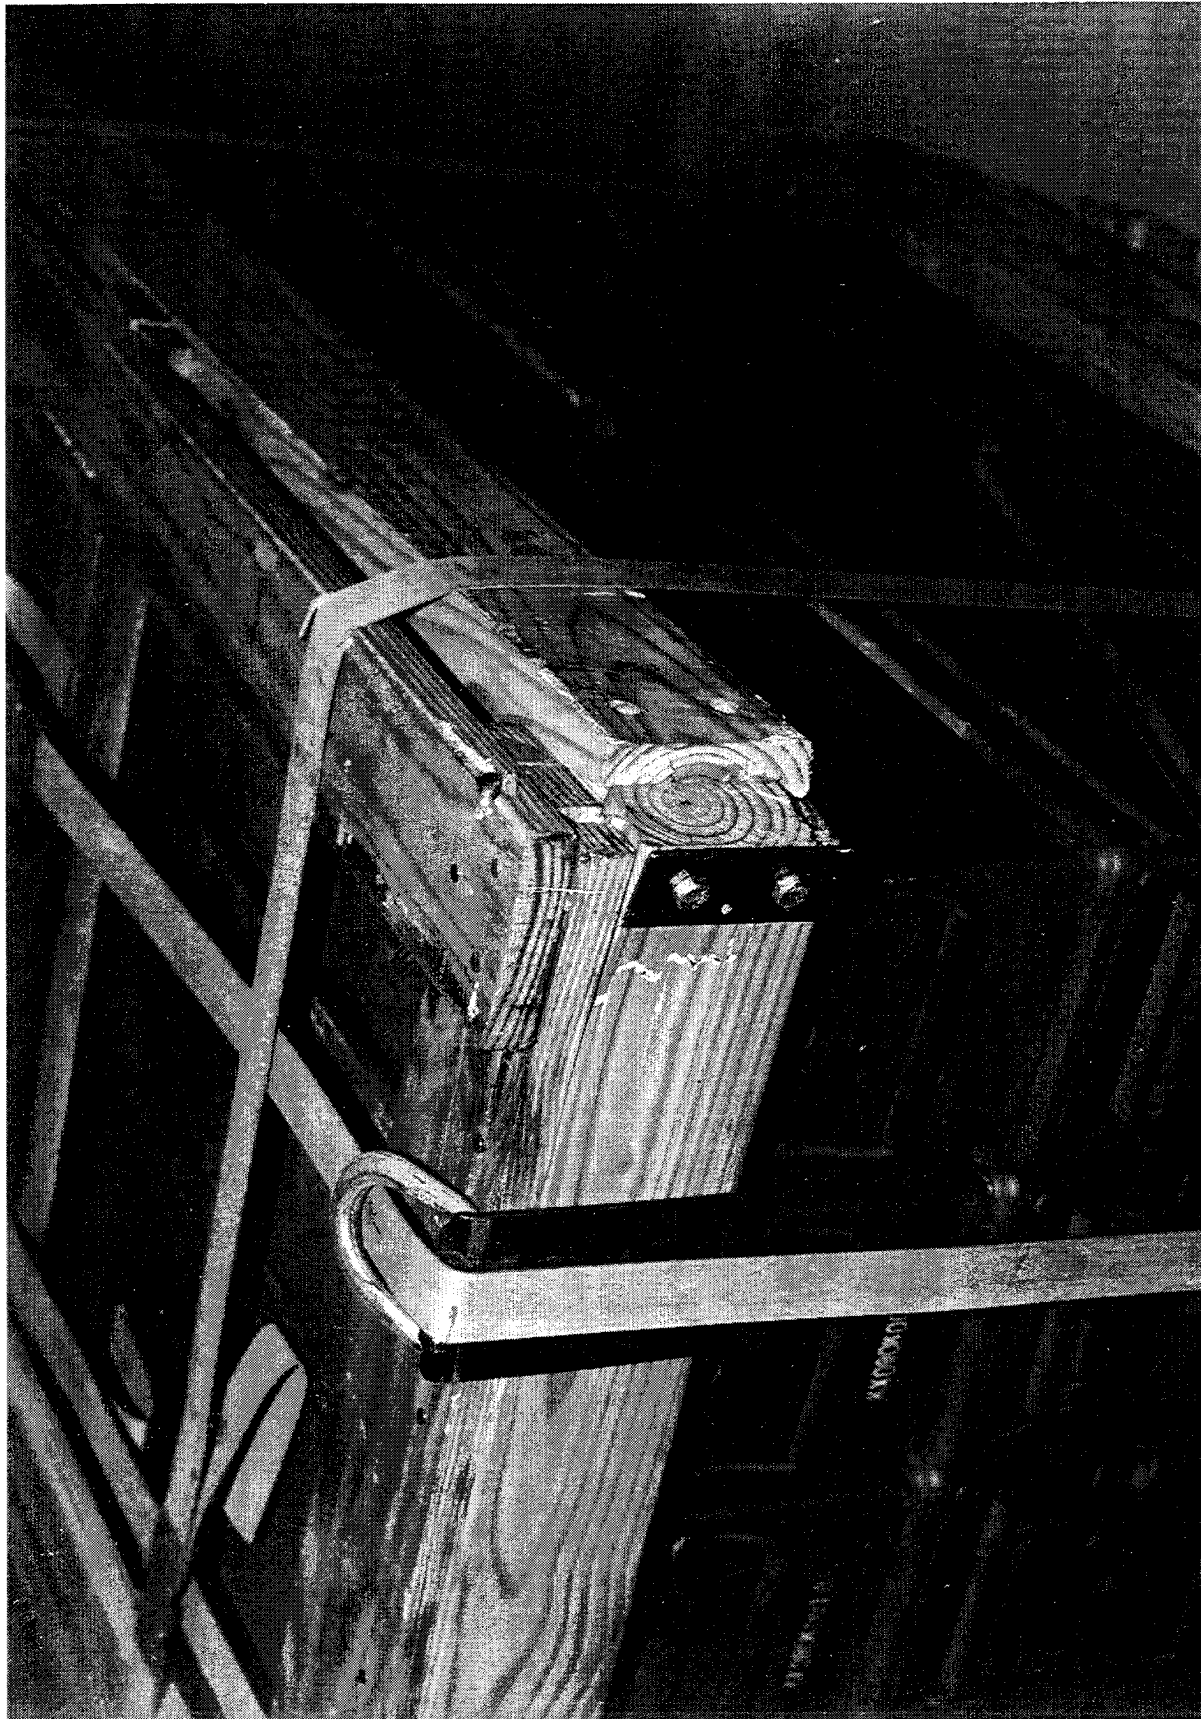
- a. The skids on the 120mm ammunition pallets rode up and under the forklift tine protector (2- by 4-inch timber) of the adjacent pallets.
- b. The vertical center gate on the 40mm ammunition side of the railcar failed.
- c. The 40mm ammunition side of the railcar top pallet adapter 2- by 4-inch timber failed due to misalignment of the adjacent pallet.
- d. Many pallet adapter boards showed cracking in and around nail holes.

U.S. ARMY DEFENSE AMMUNITION CENTER AND SCHOOL - SAVANNA, IL	
PHOTO NO. SCN94-223-4455. This photo shows a closeup view of additional damage which occurred during rail testing.

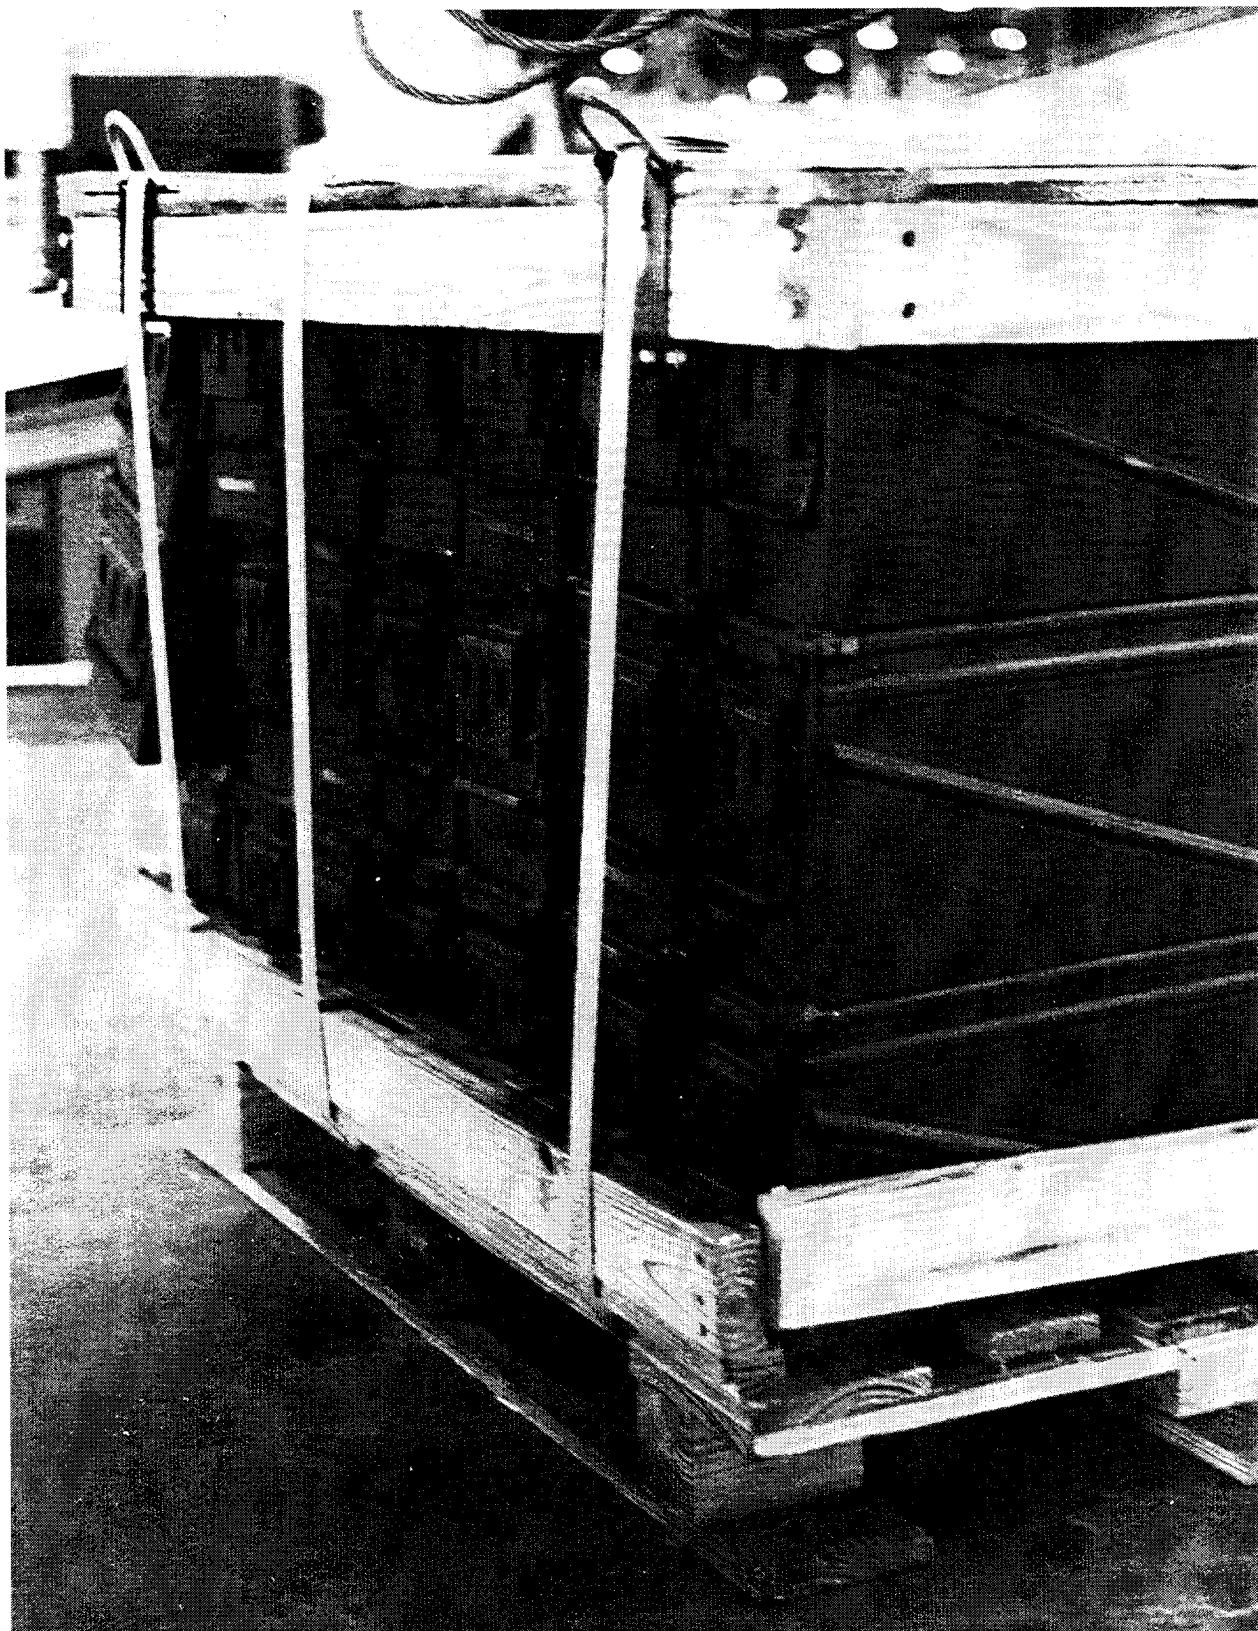
PHOTO NO. SIOAC-DEV 001. This photo shows damage to the lower pallet  
adapter following MIL-STD-1660 tests.

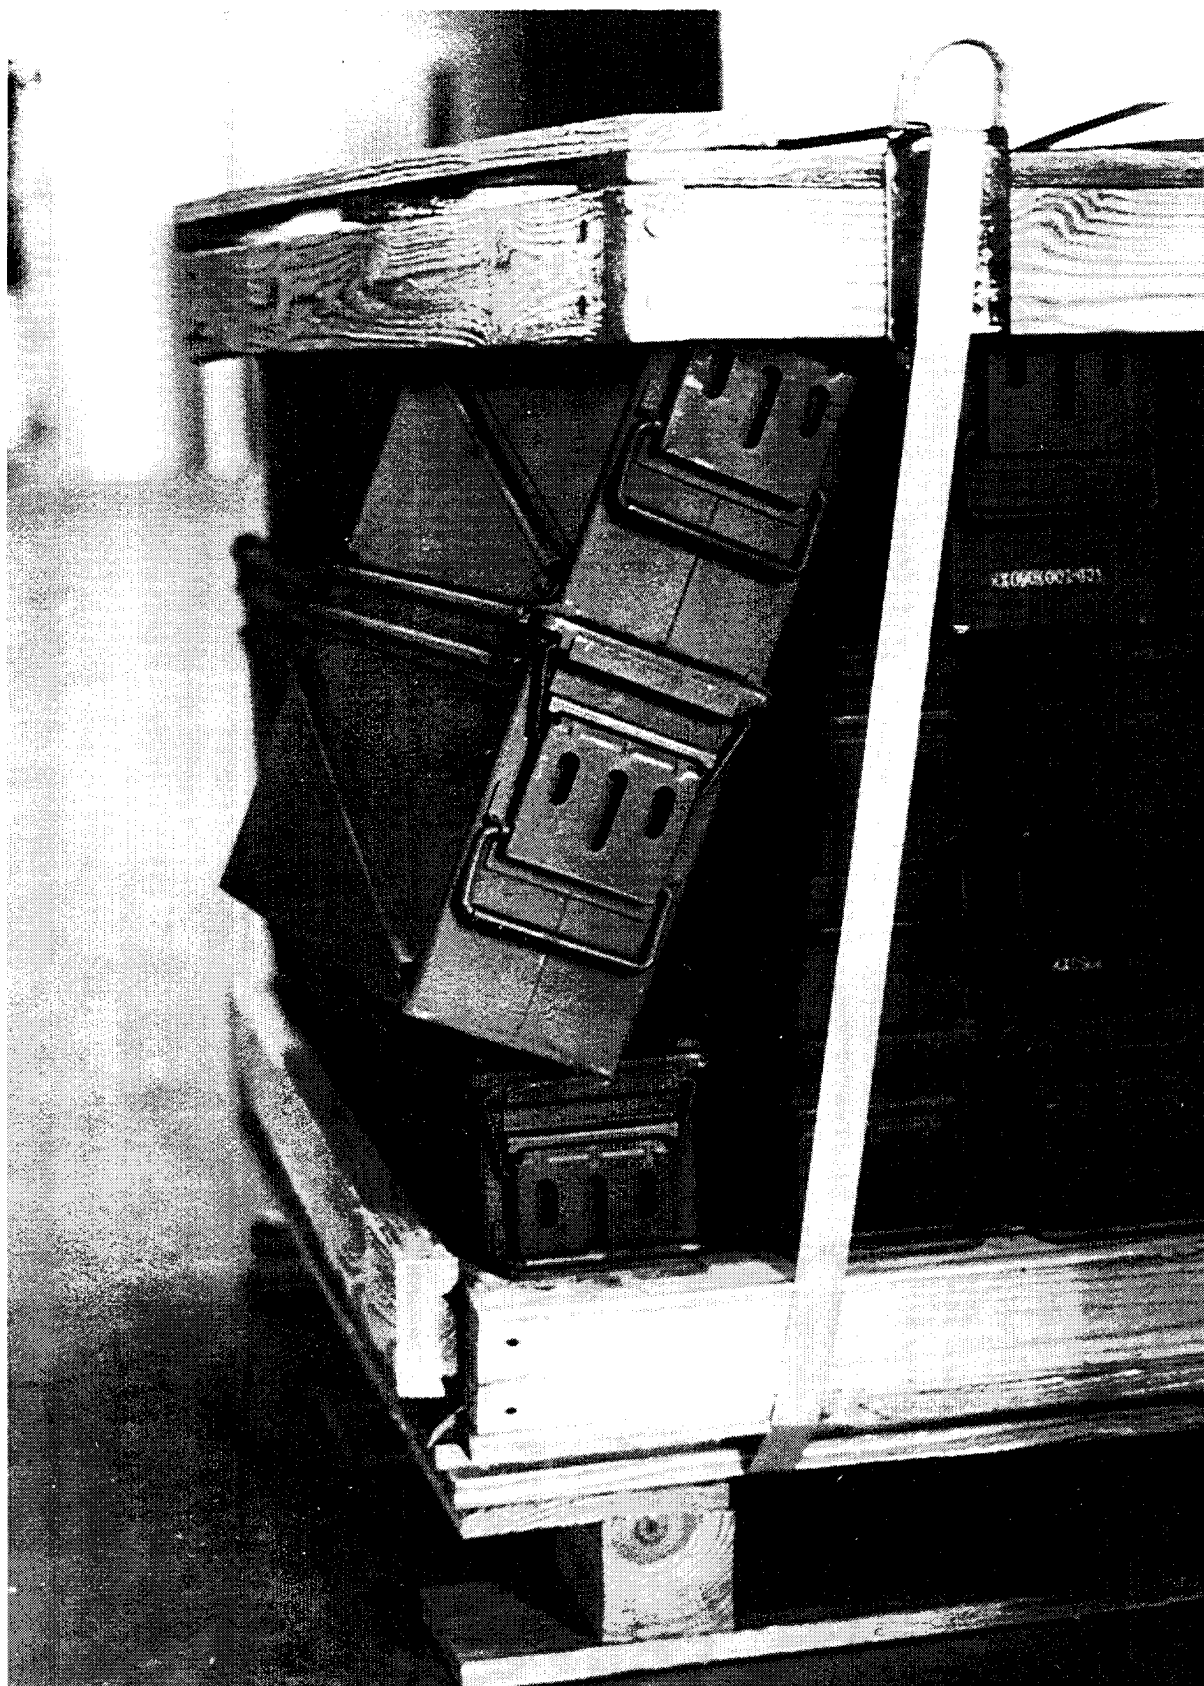
PHOTO NO. SIOAC-DEV 002. This photo shows damage to the lower pallet  
adapter following MIL-STD-1660 tests.

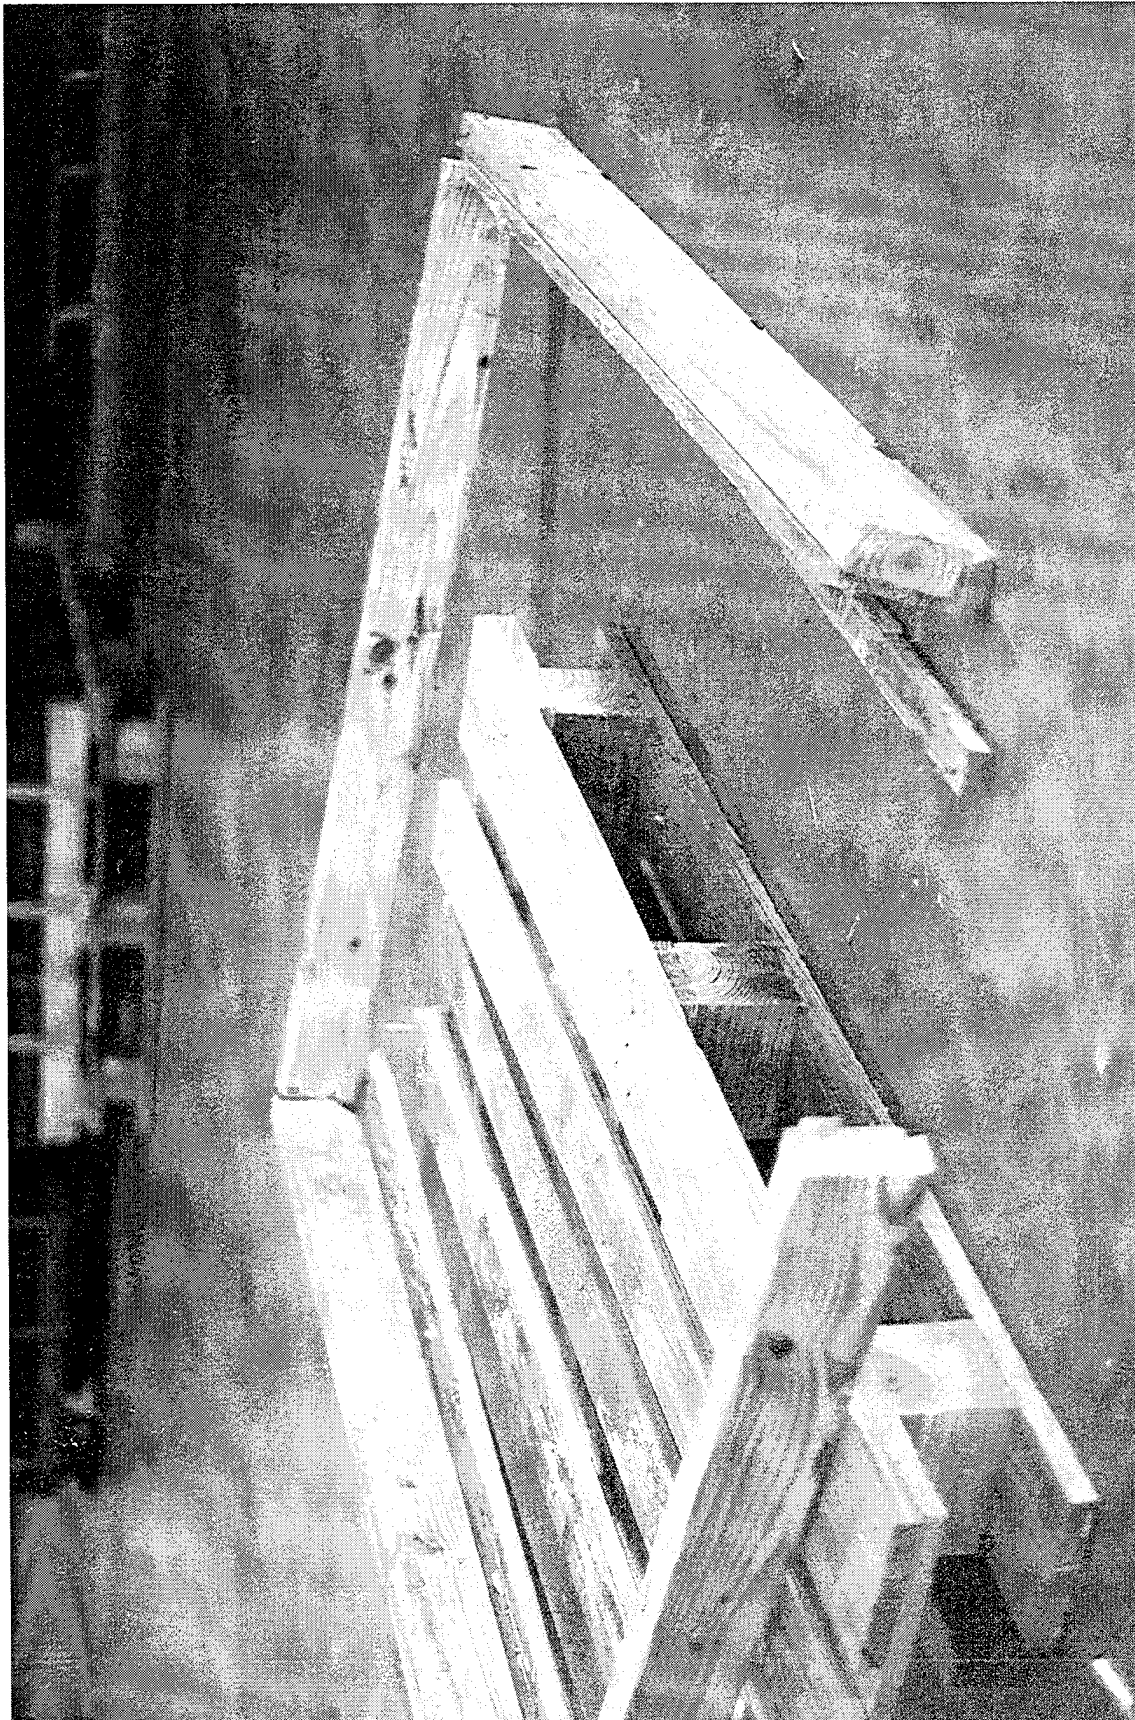
U.S. ARMY DEFENSE AMMUNITION CENTER AND SCHOOL - SAVANNA, IL	
PHOTO NO. SIOAC-DEV 003. This photo shows the total damage of the lower pallet adapter after disassembly, following MIL-STD-1660 testing.

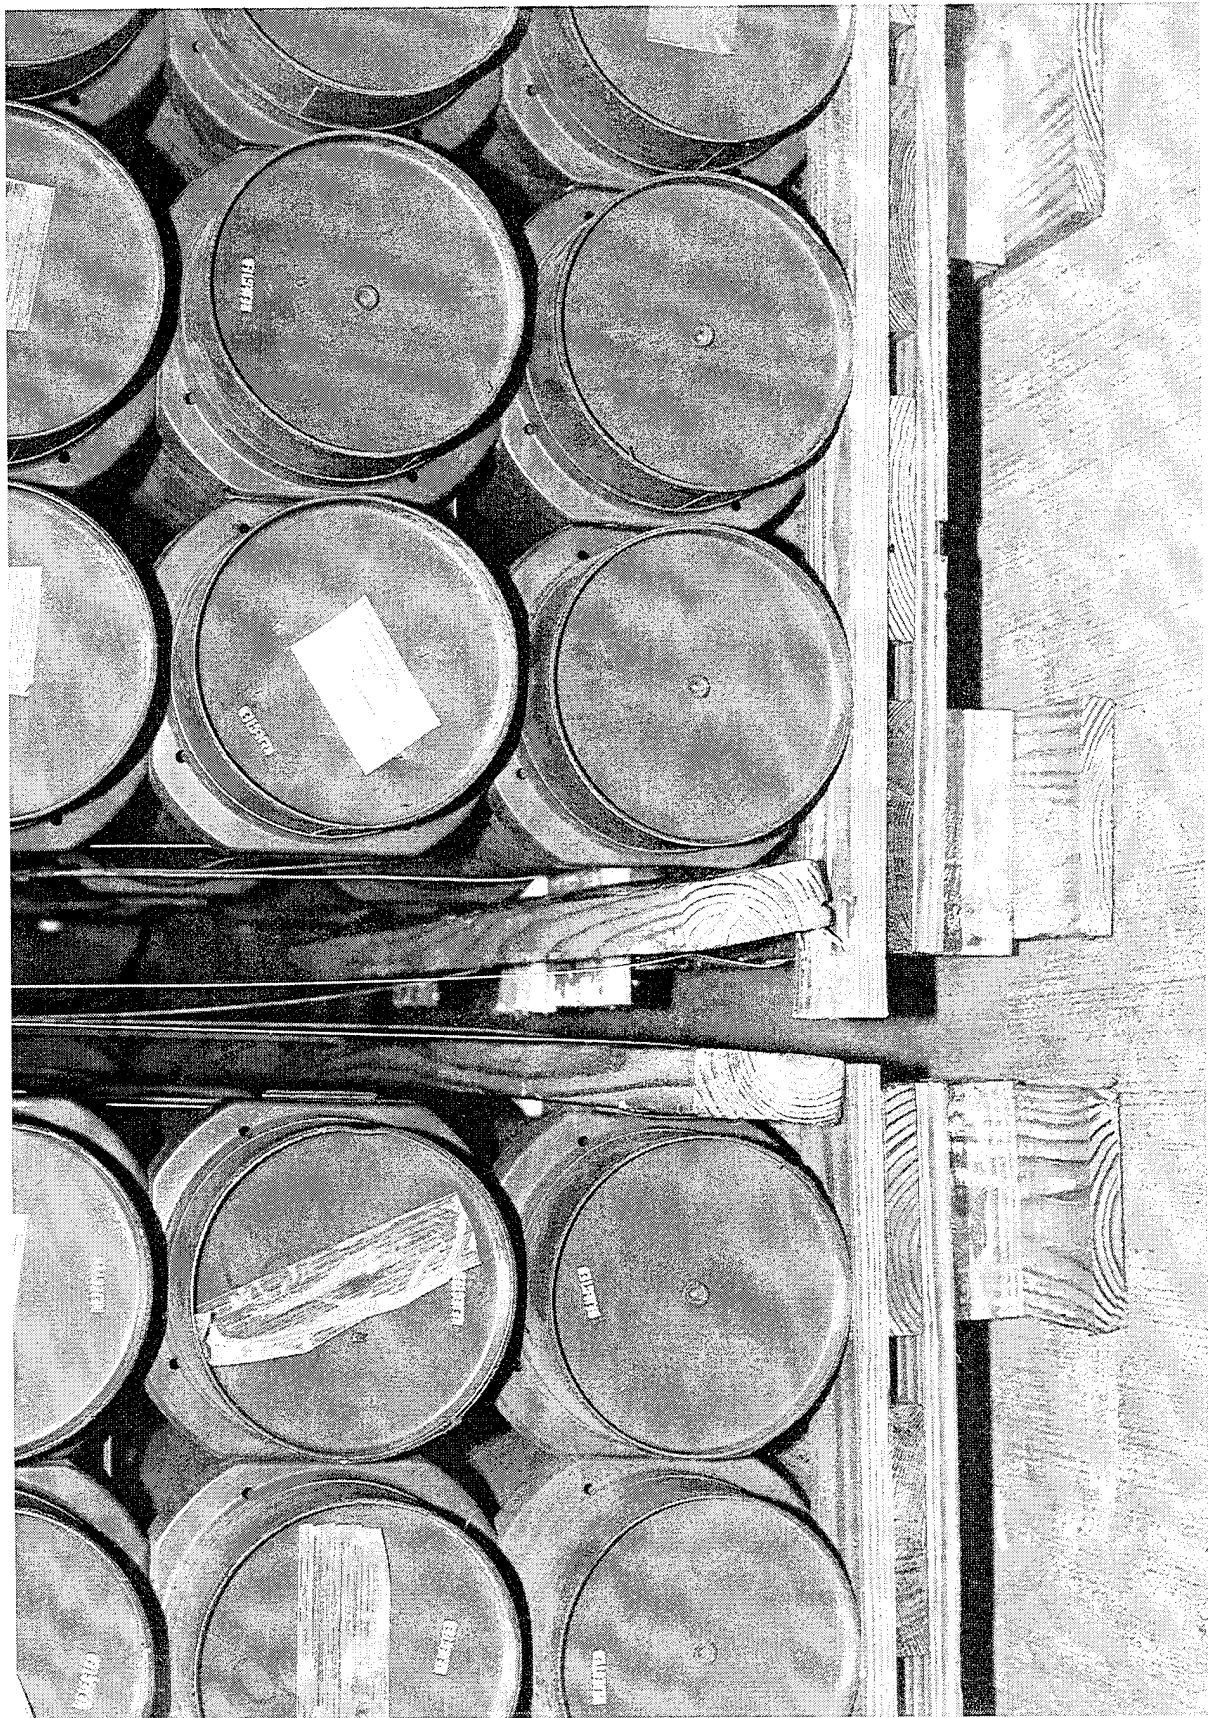
PHOTO NO. SCN94-223-4452. This photo shows the lower pallet adapter damage following rail impact testing.

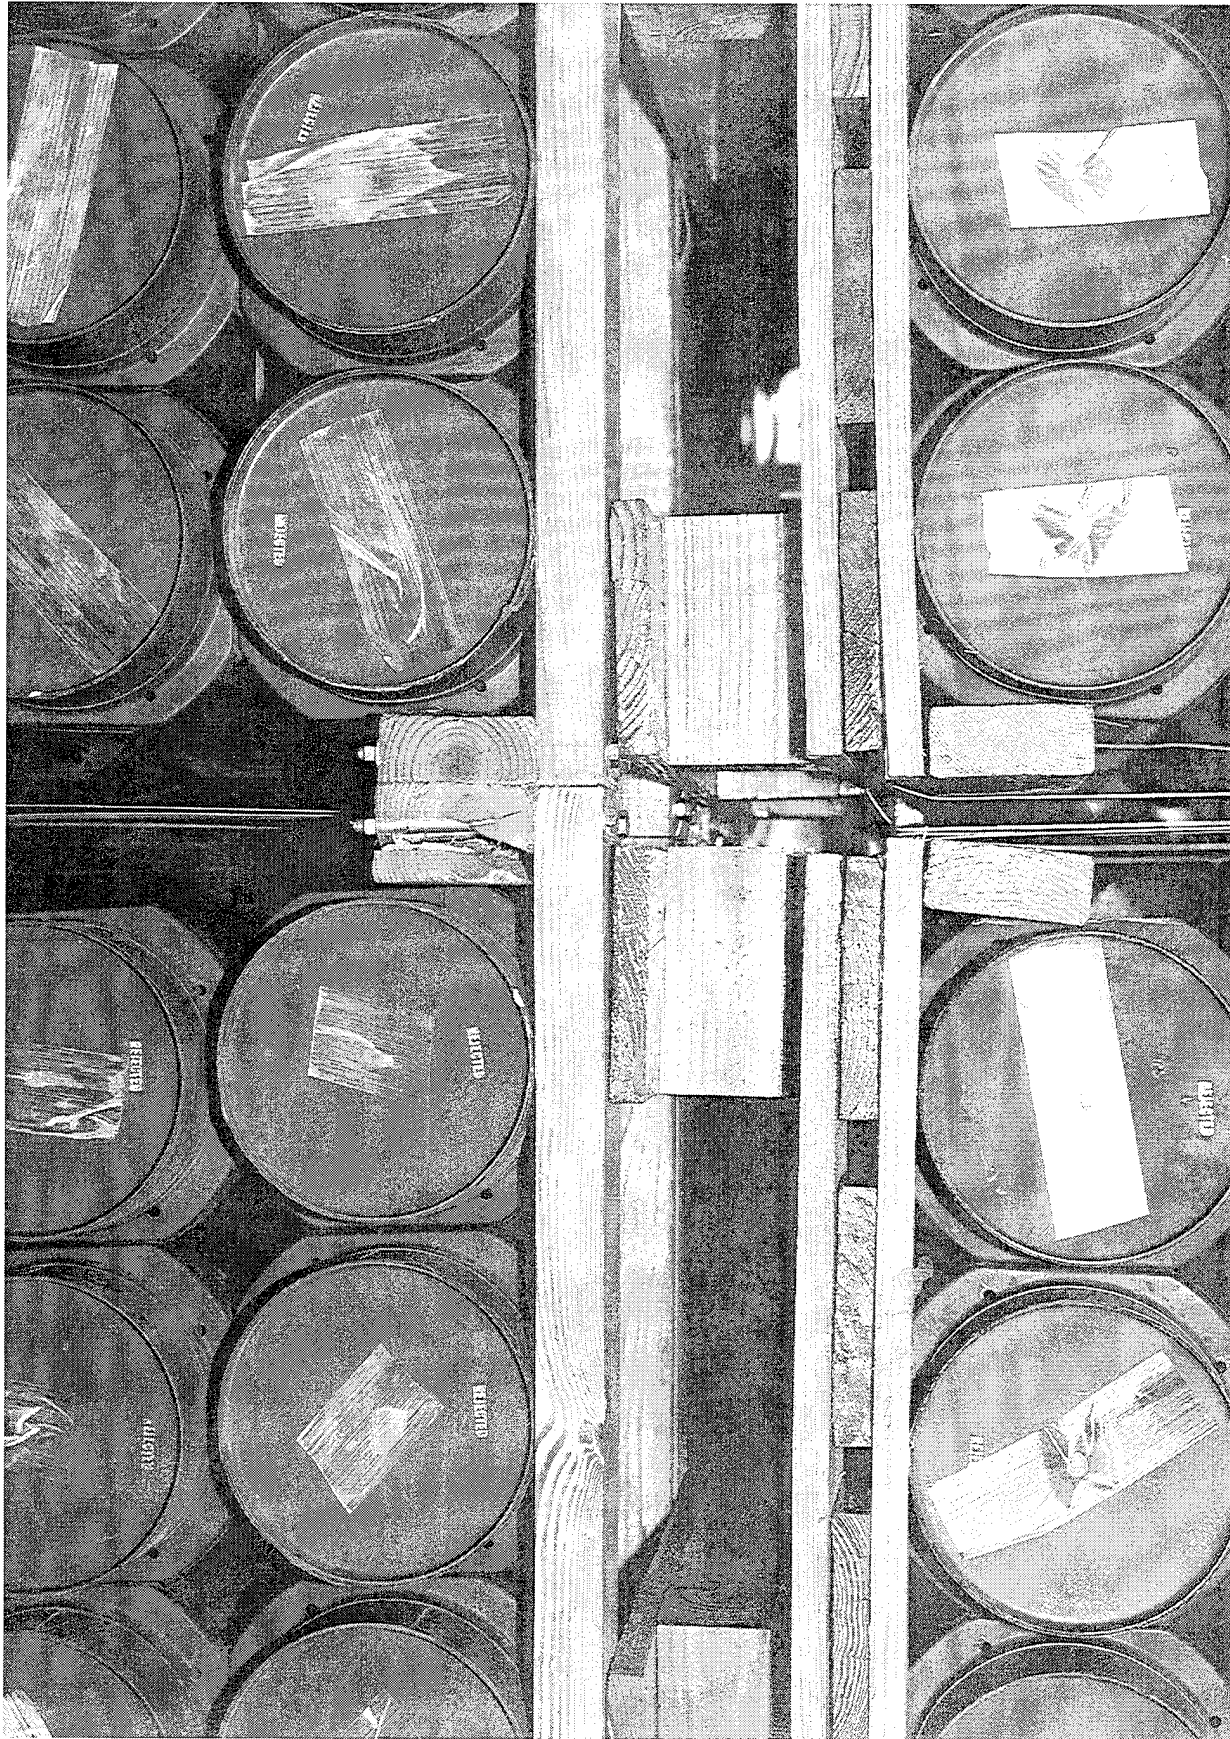
PHOTO NO. SCN94-223-4456. This photo shows the damage received to the top pallet adapter following rail impact testing. Note the bolt being pulled out of the 2- by 4-inch dimensional lumber.

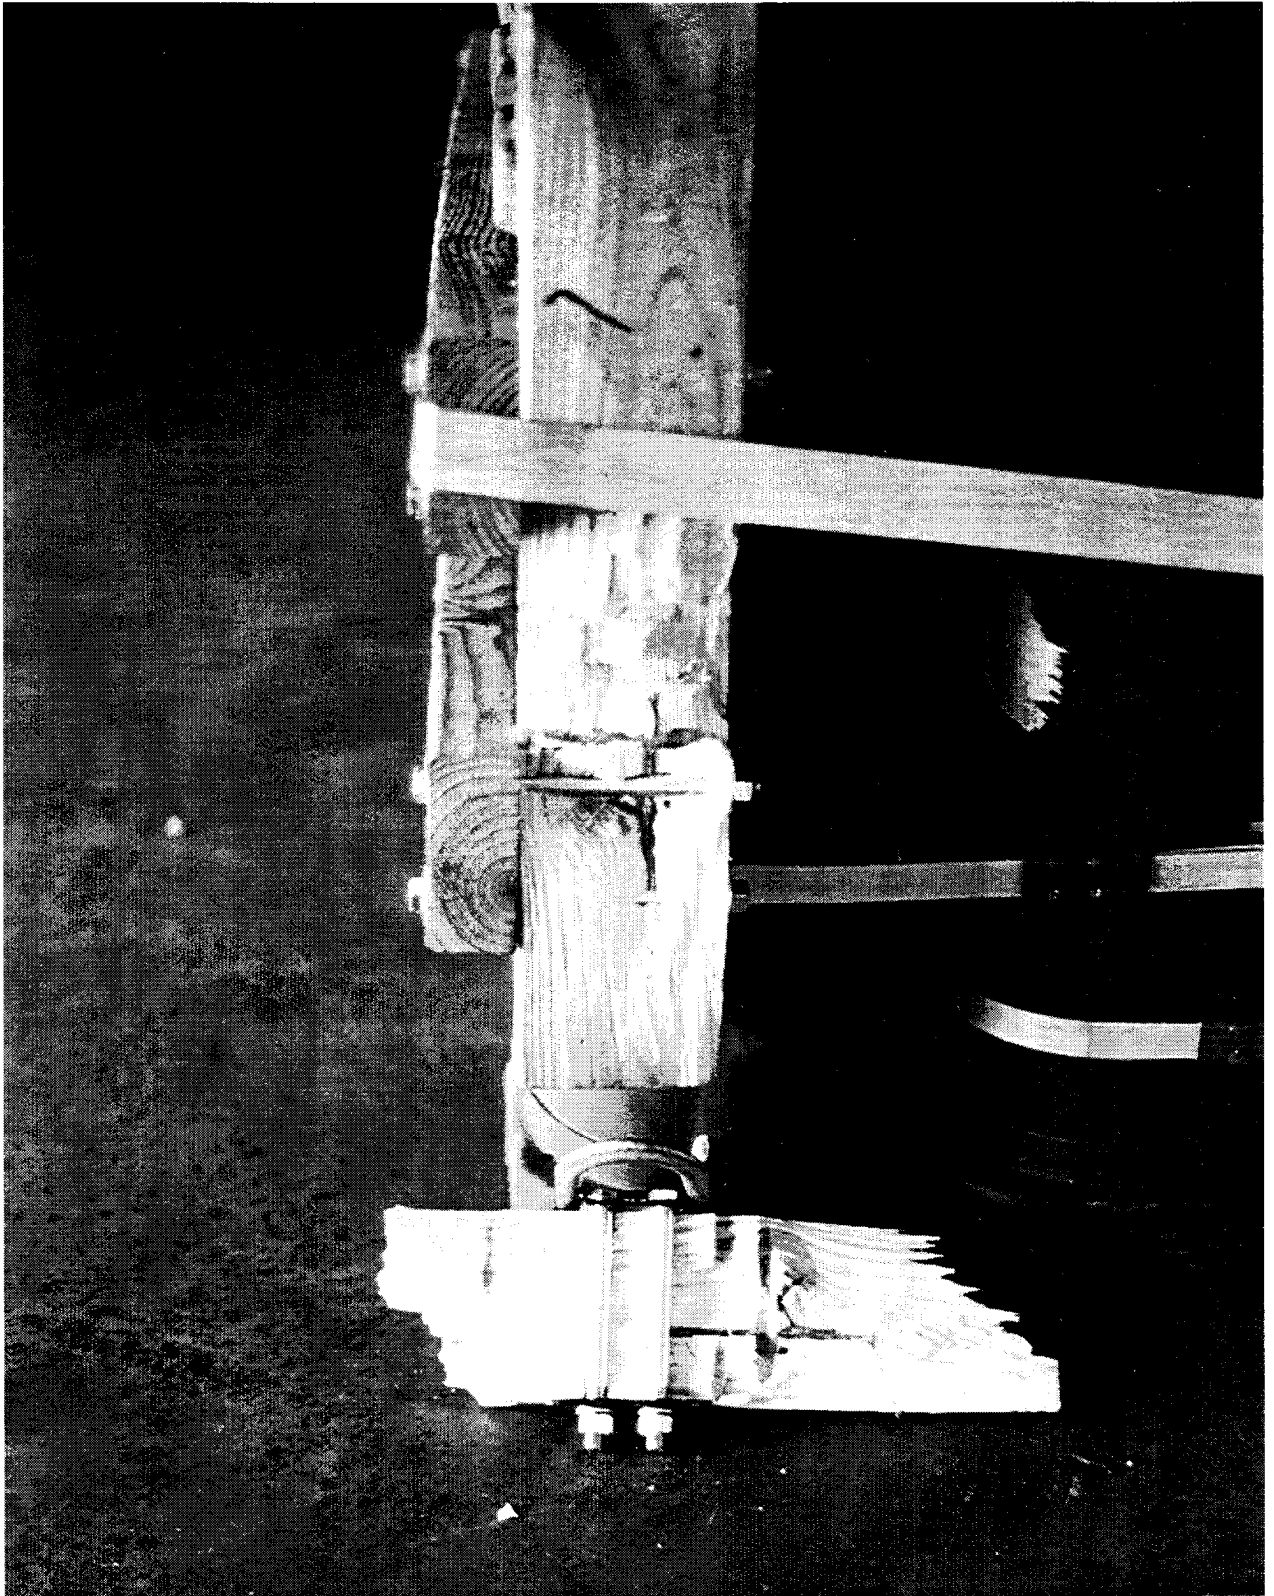
1. Catastrophic failure of one lifting ring, being pulled out of the top pallet adapter.

PHOTO NO. SIOAC-DEV-004. This photo shows the damage received to the top pallet adapter following the single-sling lifting test. Note the lifting ring being separated from the top pallet adapter.
